Thermal Spray Removal of Lead-Based Paint From the Viaduct Bridge at Rock Island Arsenal, IL

Jeffrey H. Boy, Robert A. Weber, and Ashok Kumar

CERL TR 98/119

June 1998

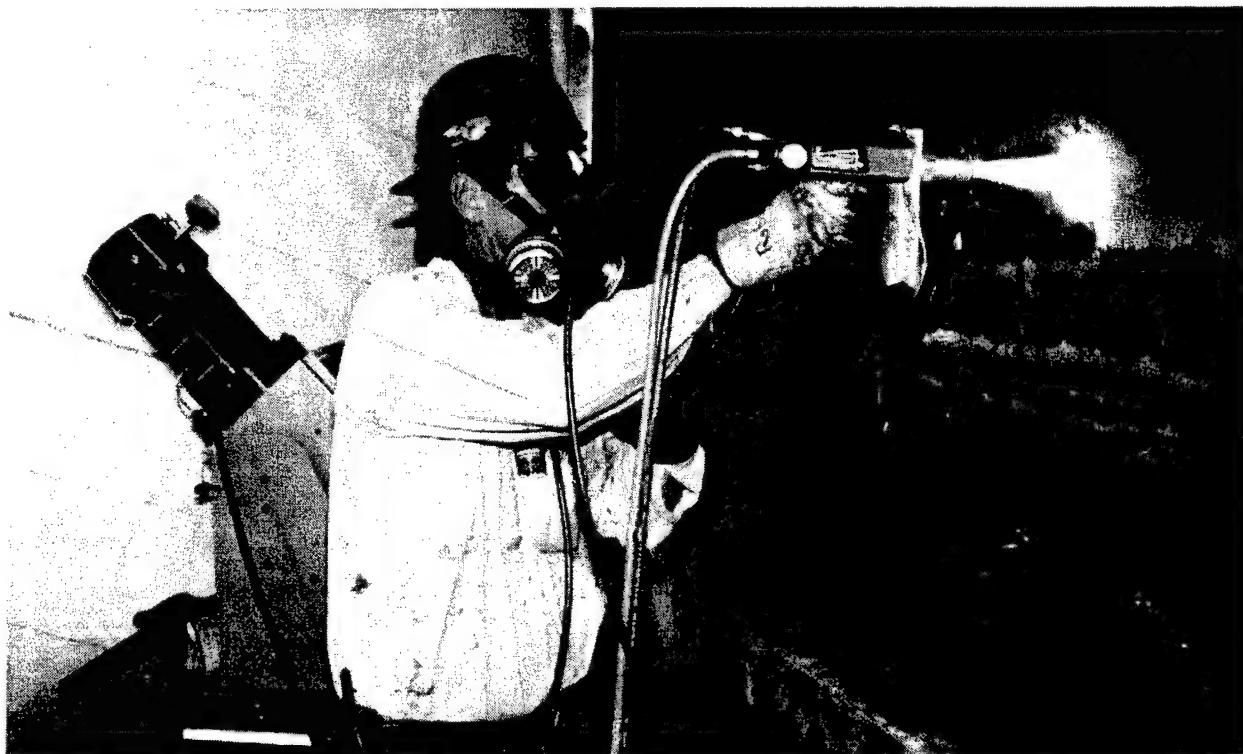
Figure C.2. TSV technology in use to remove lead-based paint from the Viaduct Bridge at Rock Island Arsenal.

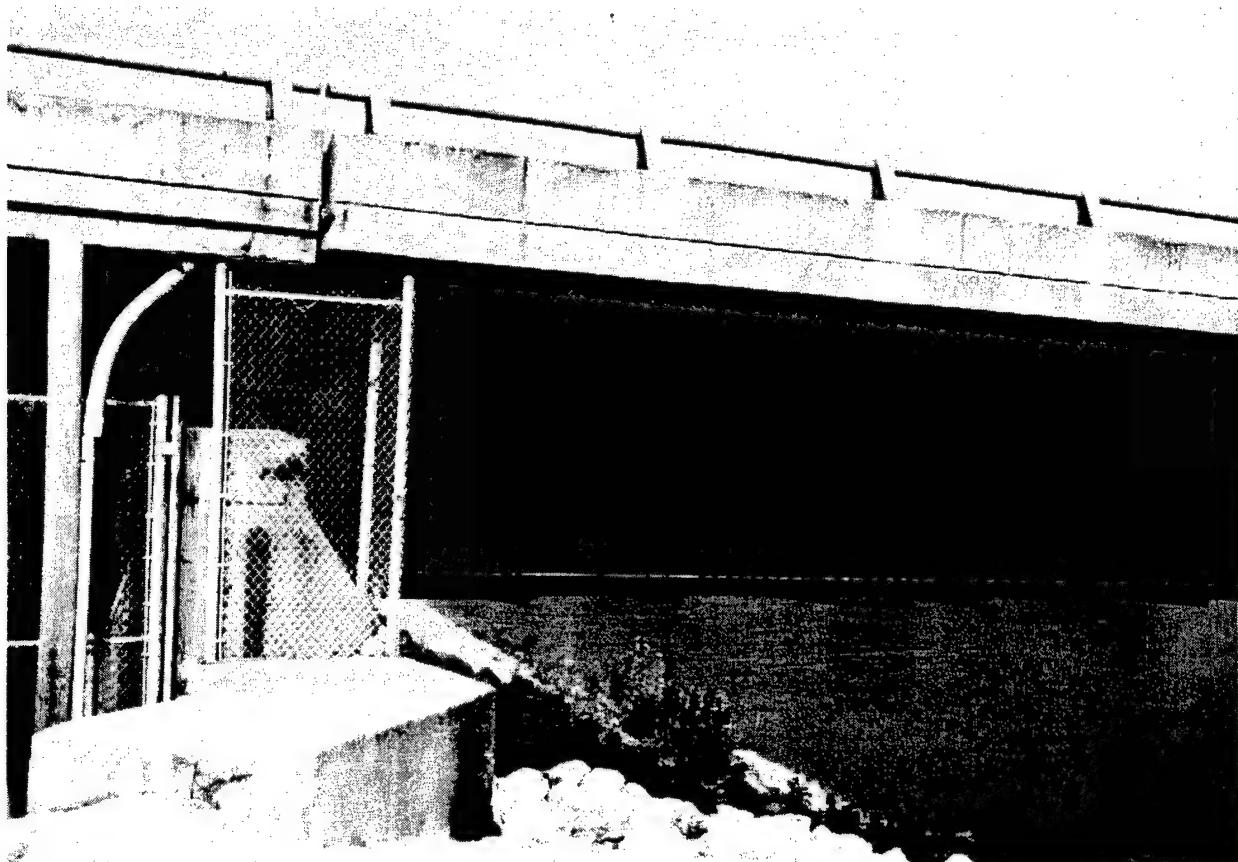
Figure C.7. The Viaduct Bridge after completion of TSV demonstration.

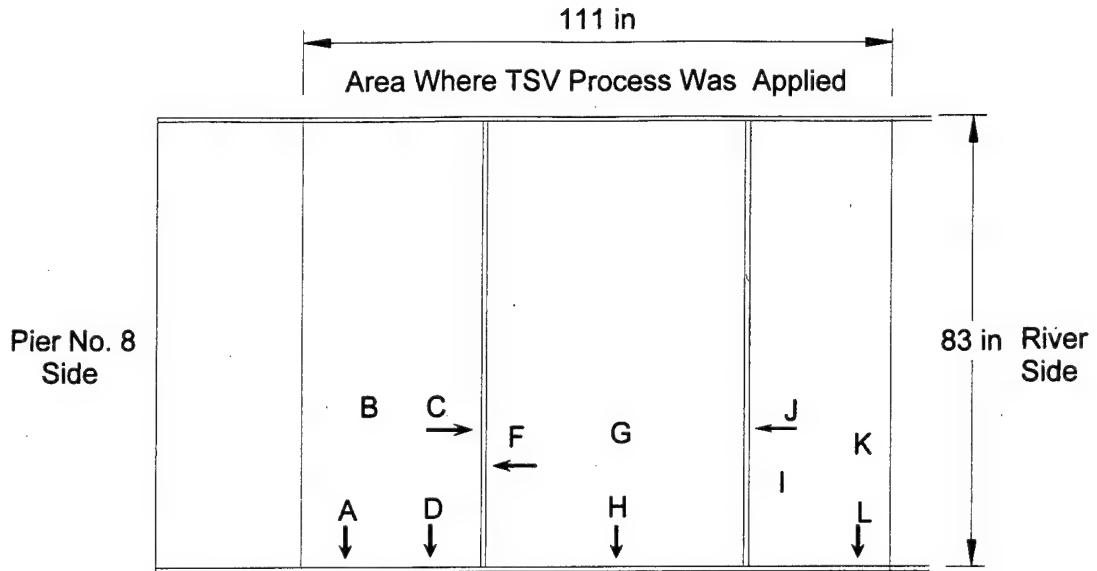
Figure D.1. Location of thickness measurements of existing paint system before application of TSV process (east side).

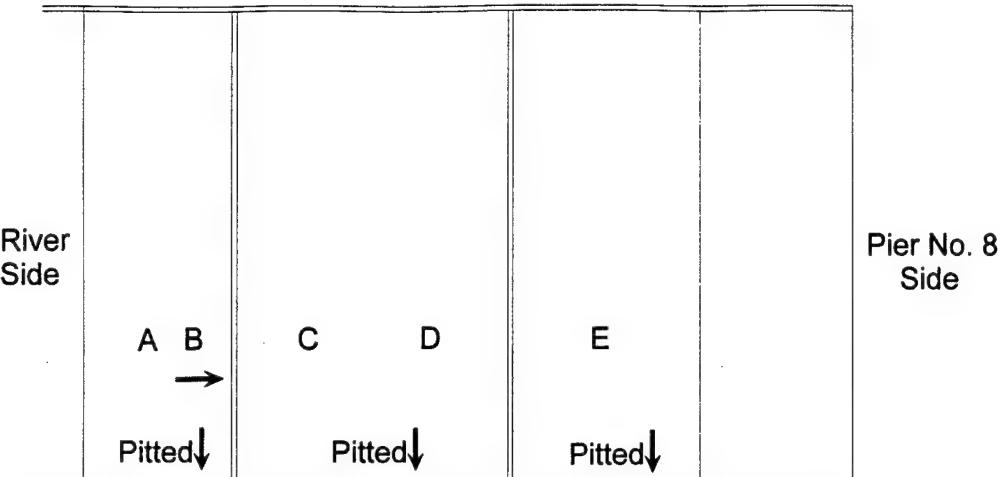
Figure D.2. Location of thickness measurements of existing paint system before application of TSV process (west side).

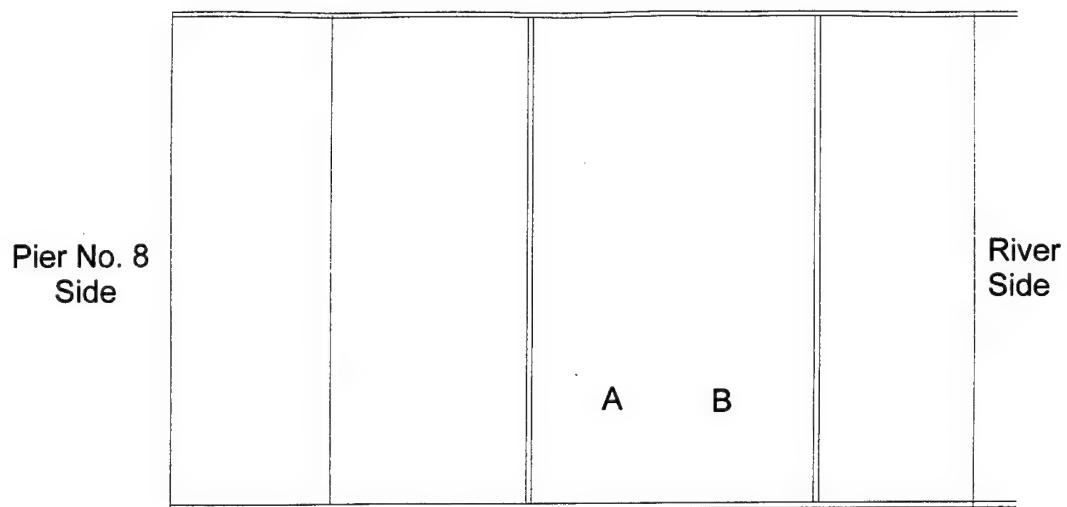
Figure D.3. Location of steel temperature measurements during application of TSV process.

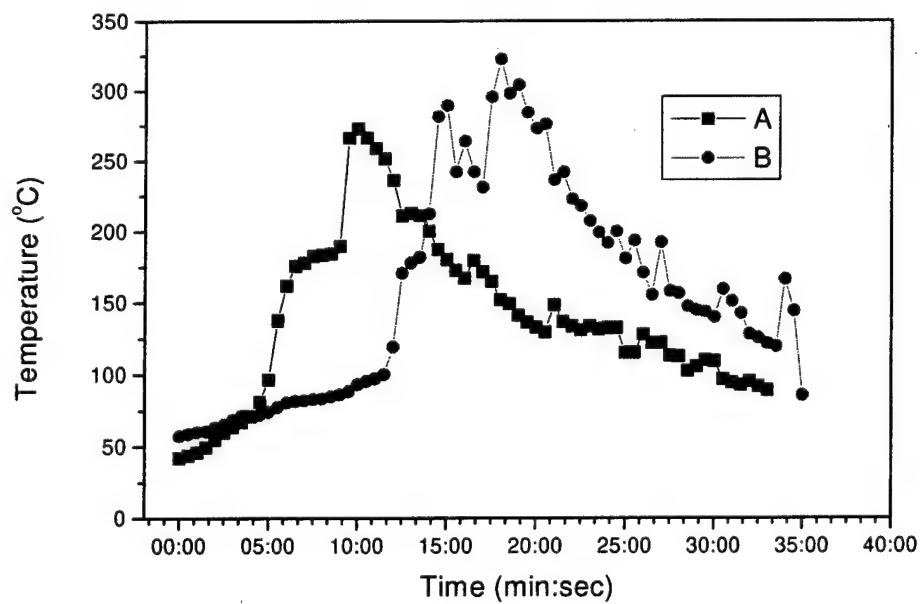
Figure D.4. Steel temperature measurements during application of TSV process.

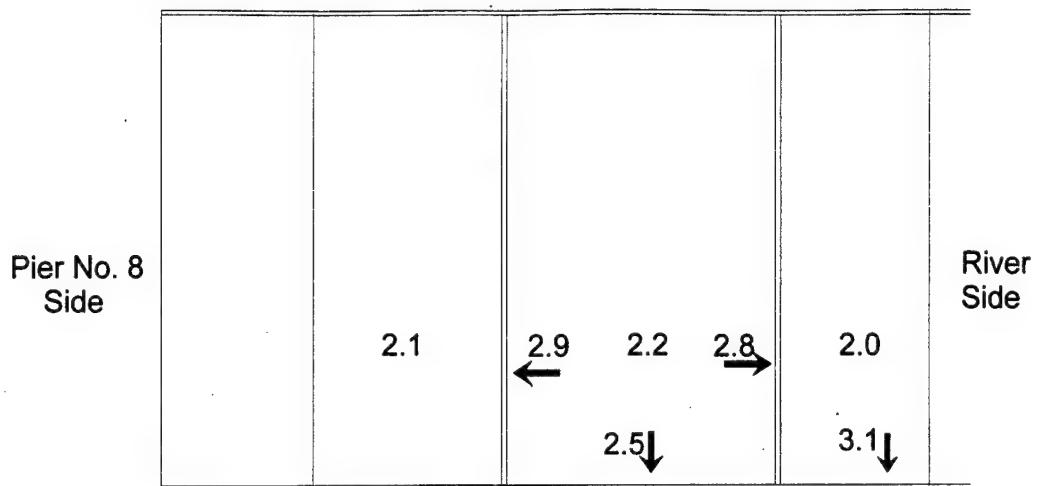
The TSV process met the principal performance criterion of providing surface preparation for repainting. Following application of the TSV process, the surface was inspected by CERL personnel and was found to meet the requirements of SSPC SP1 and SP3 required in the contract specification, and it also was suitable for repainting with a surface-tolerant coating system. The surface profile was measured using ASTM D 4417 and found to range from 2.0 to 3.0 mils (Figure D.5 and D.6).

Figure D.5. Surface profile after application of TSV process in mils (east side).

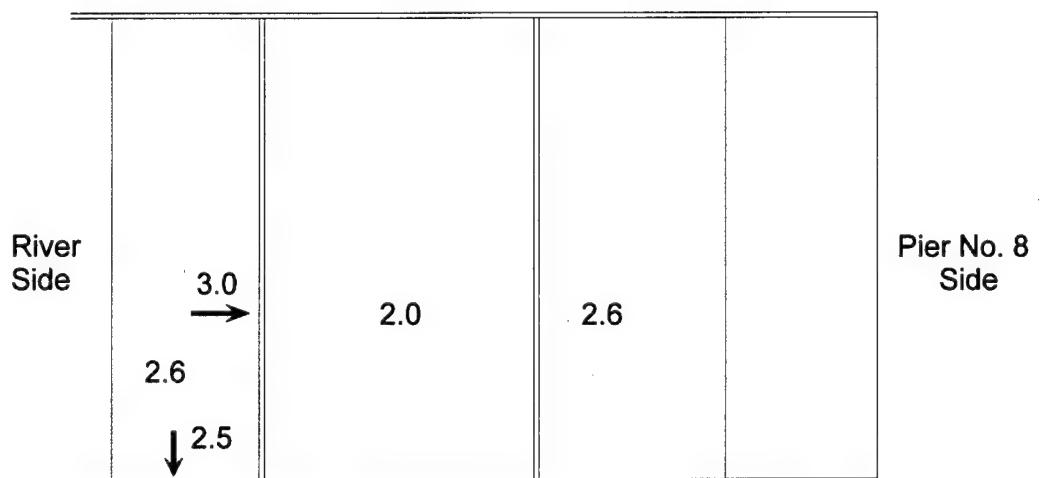
Figure D.6. Surface profile after application of TSV process in mils (west side).

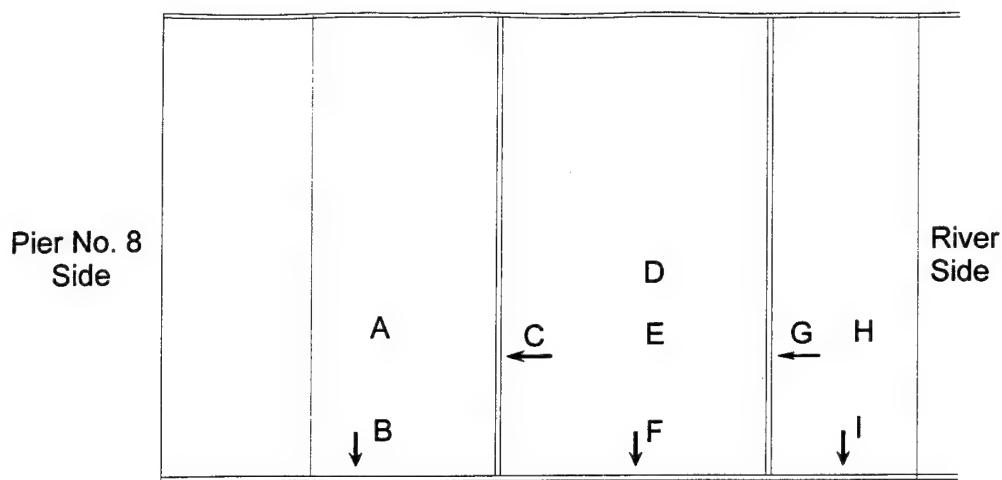
Figure D.7. Location of thickness measurements of the primer after application of TSV process (east side).

Location	Sample 1 (mils)	Sample 2 (mil)	Sample 3 (mils)	Average
A	2.4	2.2	1.9	2.2
B	4.3	4.4	4.7	4.4
C	2.6	2.5	2.0	2.4
D	1.5	1.8	1.8	1.7
E	2.5	2.4	2.7	2.5
F	4.3	3.6	2.4	3.4
G	3.3	3.2	3.9	3.4
H	2.5	2.1	2.8	2.5
I	1.7	1.8	2.1	1.9

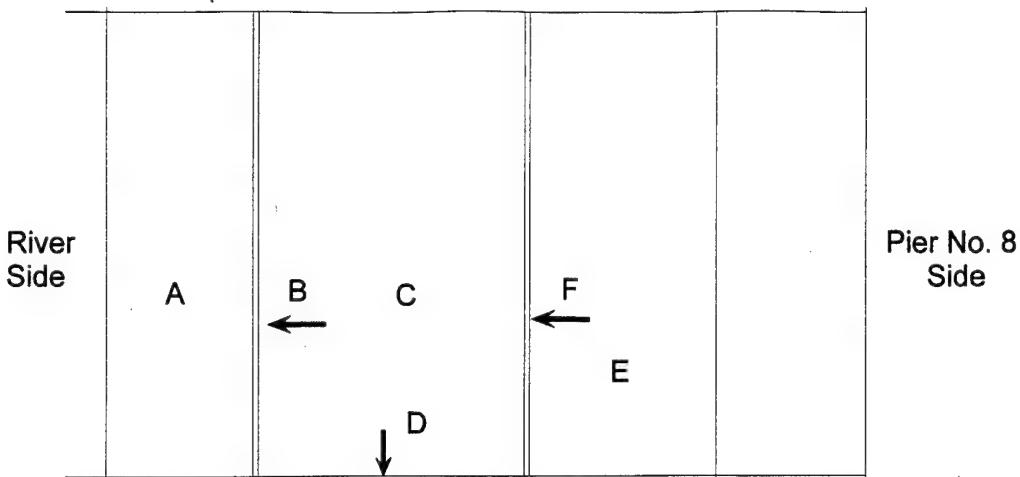
Figure D.8. Location of thickness measurements of the primer after application of TSV process (west side).

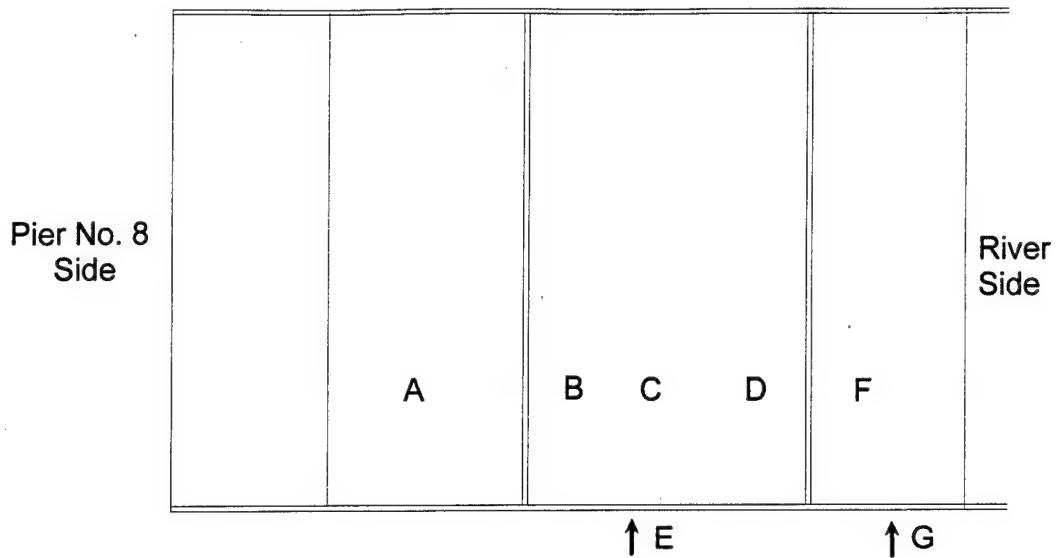
Temperature and relative humidity were measured before painting. The temperature of the substrate was more than 5 °F higher than the dew point, and the relative humidity was less than 80 percent before painting commenced. The contract specification required a spread rate of 500 sq ft per gal. One gal of primer and 1.5 gal of paint were used to apply one coat of the primer and two topcoats over the 180 sq ft area of the demonstration. The measured thickness of the dried primer ranged from 1.7 to 3.4 mils, and was on average 3.0 mils (Figures D.7 and D.8). The measured thickness of the completed coating system (primer plus topcoats) ranged from 5.4 to 8.4 mils, and was on average 6.9 mils (Figures D.9 and D.10).

Figure D.9. Location of thickness measurement of primer plus topcoats after application of TSV process (east side).

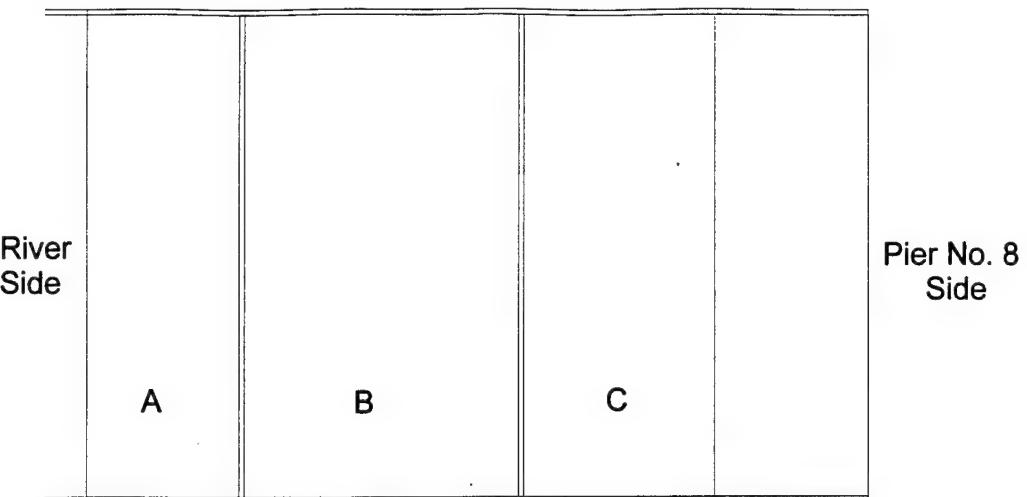
Figure D.10. Location of the thickness measurements of primer plus topcoat after application of TSV process (west side).

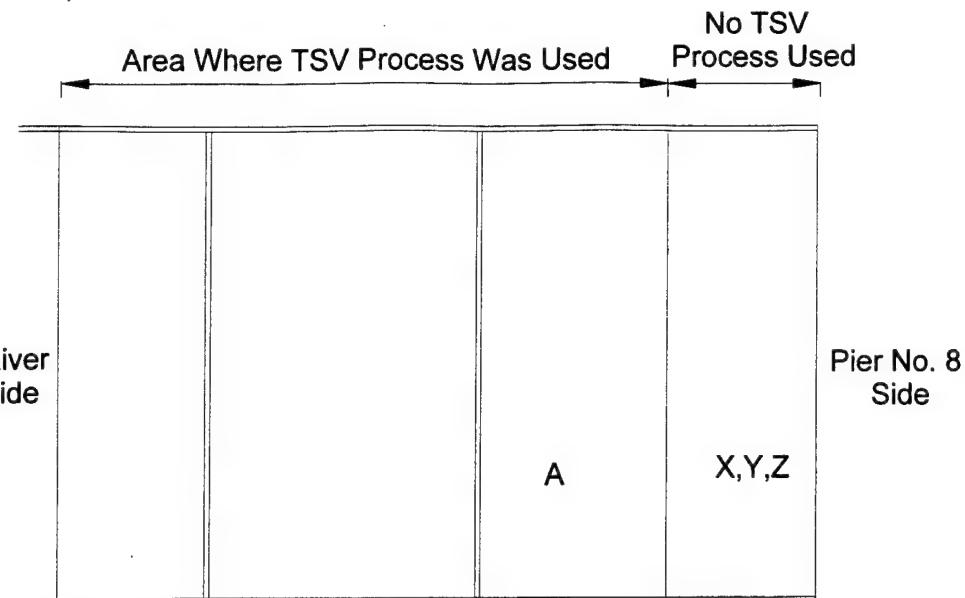
X-ray fluorescence analysis found that the lead concentration in areas adjacent to the demonstration with original coating intact ranged from 4.7 to 5.8 mg/sq in. (Figure D.11). In areas on which TSV was demonstrated, the measured lead concentration was found to range from 1.0 to 2.1 mg/sq in. (Figures D.12 and D.13). As with most other paint removal processes, such as chemical removal, some residual lead was present on the surface. The retention of lead on the steel surface is a function of the experience of the TSV applicator, the original amount of lead present, and the number of TSV applications used. In this demonstration, two applications were used. Additional applications of the process would be expected to further reduce the residual lead concentration. Also, it is reasonable to expect that lead removal will be more complete as operators gain experience with the technology. The workers in the current test had

Figure D.11. Location of measurements for lead concentration using x-ray fluorescence spectroscopy with and without application of the TSV process (west side).

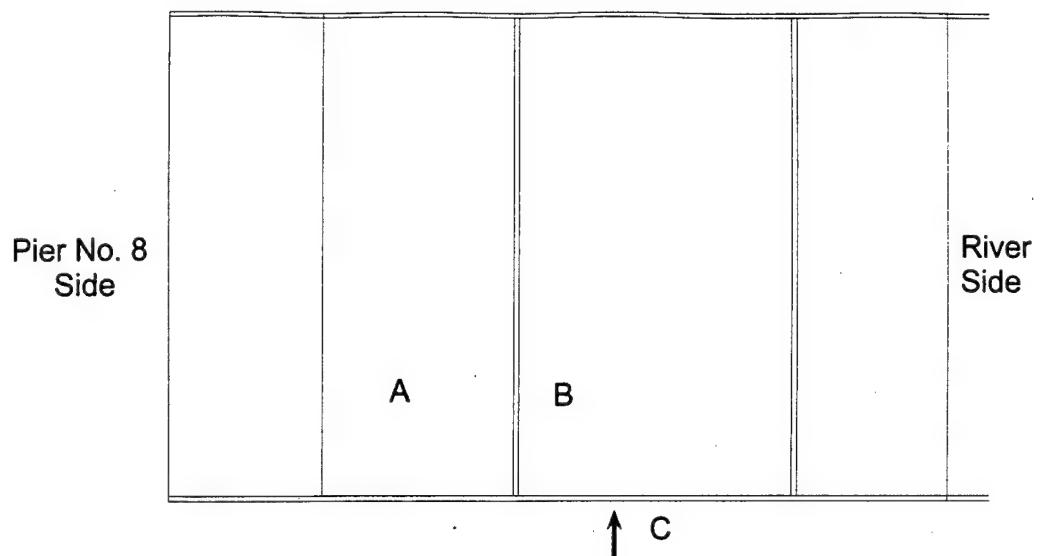
Figure D.12. Location of measurements for lead concentration after application of the TSV process.
